**Flood Control Project Maintenance
Levee Inspections**
LMA District Cover Sheet
Spring 2018 Levee Inspection Results

Reclamation District No. 0349 Sutter Island

Spring 2018 Levee Inspection Results

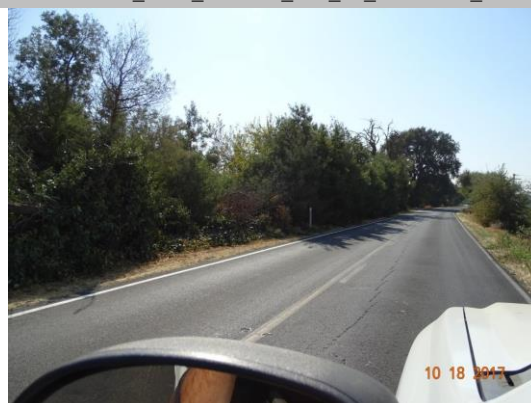
Photo 1 of 1 : SP_2018_RD0349_204_13_20180305_00003.jpg

Waterside vegetation should be cleared to 20 feet from crown for inspection and access.

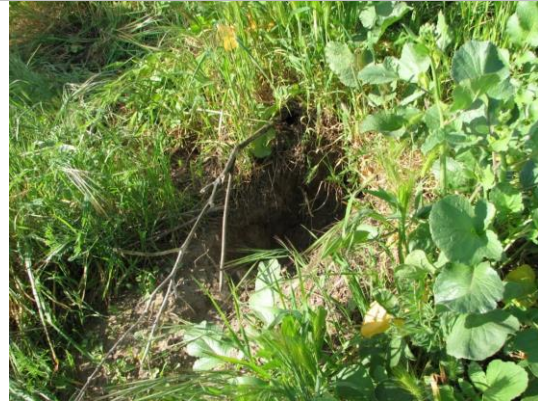
Photo 3 of 3 : UCIP_SP_2018_50062_36548.jpg

Dense burrow activity--10 inch hole present.

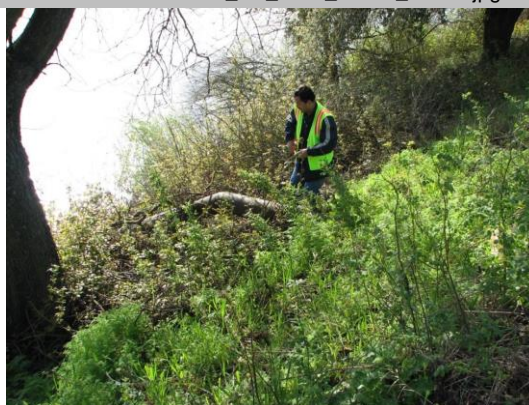
Photo 1 of 3 : UCIP_SP_2018_21572_36576.jpg

View of pipe crossing located on waterward side--dense vegetation on levee slope.

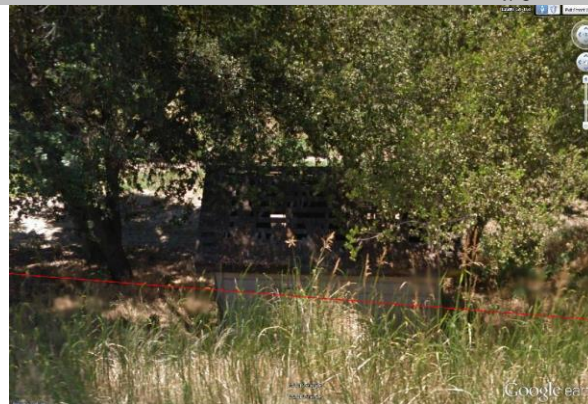
Photo 2 of 3 : UCIP_SP_2018_44304_73625.jpg

Pumphouse on LS toe (From google view)

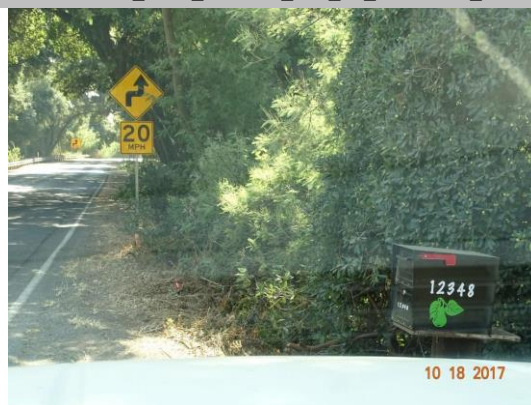
Photo 1 of 1 : SP_2018_RD0349_204_33_20180305_00014.jpg

Landside landscaping should be thinned and maintained to allow inspection and access to levee slope and toe.

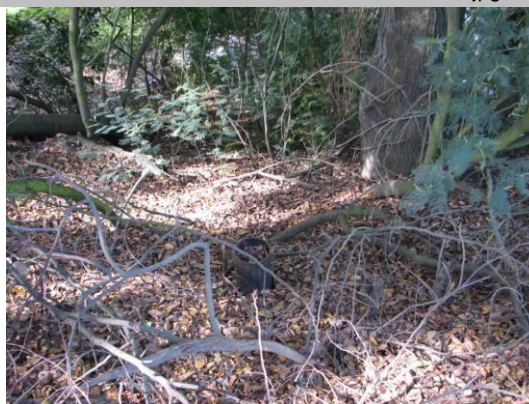
Photo 2 of 3 : UCIP_SP_2018_44214_36571.jpg

Pipe located on landward side--unable to determine whether it belongs to crossing.

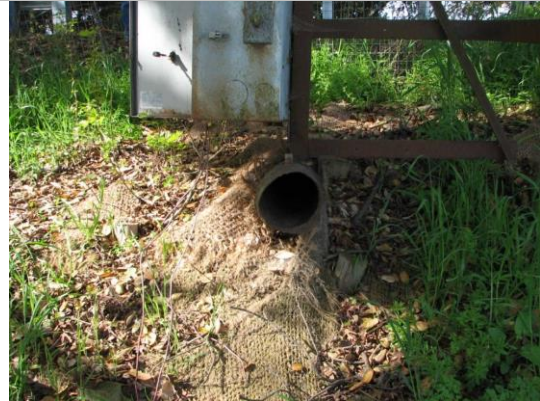
Photo 3 of 3 : UCIP_SP_2018_44214_36570.jpg

View of pipe at waterward shoulder with control box.

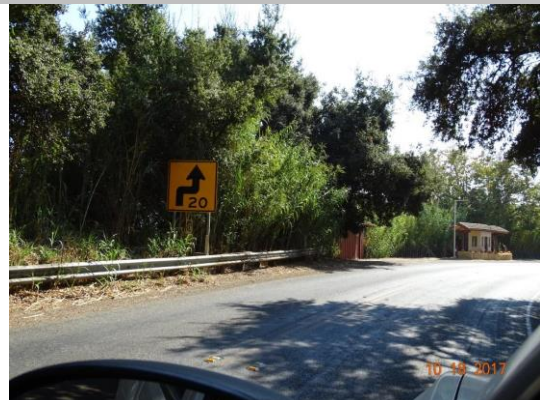
Photo 1 of 1 : SP_2018_RD0349_204_34_20180305_00015.jpg

LM Start	1.54	Rating **	U	Issue No.	34
LM End	1.58	Issue Type +	Ma	Location *	WS
Category	Earthen Levee			GPS Latitude/Longitude	
				Start	End
Item	Vegetation			38.305772 °	38.305252 °
				-121.574763 °	-121.574791 °
DWR ID	DWR_RD0349_01_f_2017_34				
Comment Code					
V2 : Remove the wild growth other than native grasses from the levee slopes.					
Inspector Comment					
Arundo completely blocks visibility and access to waterside of levee.

Arundo completely blocks visibility and access to waterside of levee. Must be removed.

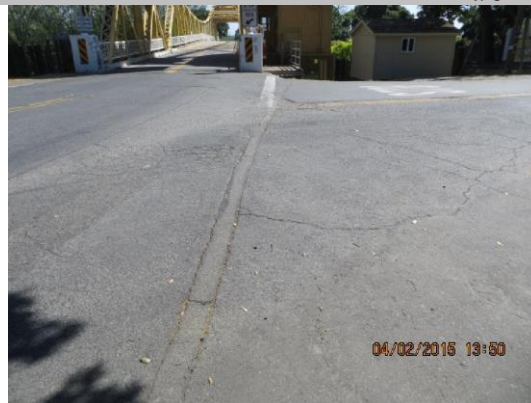
Photo 1 of 3 : UCIP_SP_2018_46168_74542.jpg

Cut in pavement good indicator of pipe location.

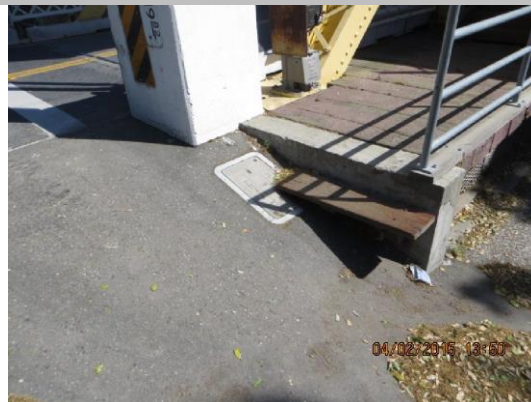
Photo 2 of 3 : UCIP_SP_2018_46168_74543.jpg

Christy box on WS shoulder.

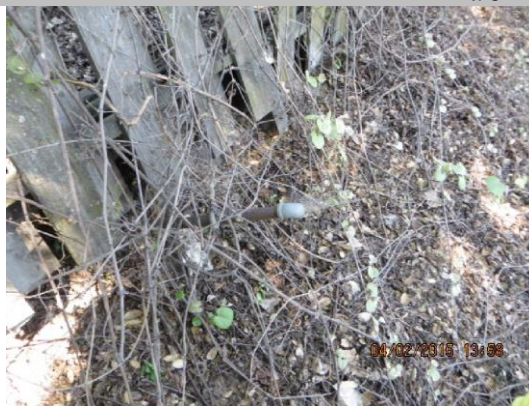
Photo 1 of 3 : UCIP_SP_2018_46169_74545.jpg

Pipe visible at base of fence on WS shoulder.

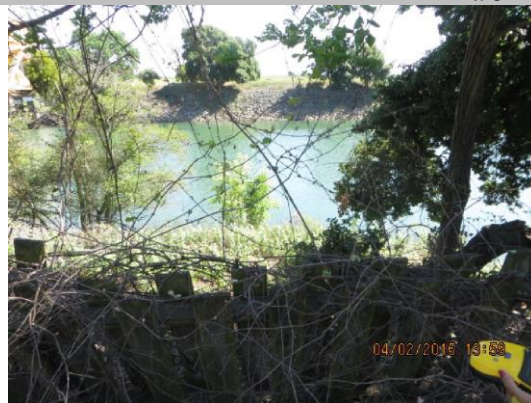
Photo 2 of 3 : UCIP_SP_2018_46169_74546.jpg

Fence on WS shoulder.

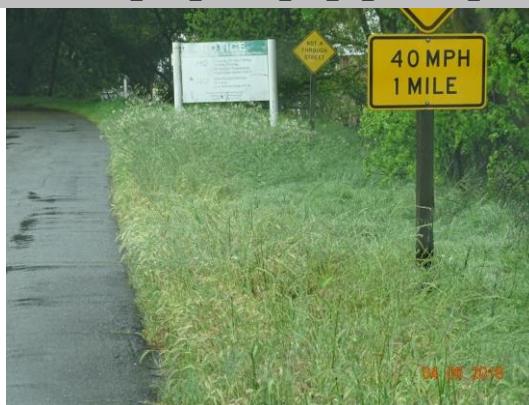
Photo 1 of 1 : SP_2018_RD0349_205_45_20180409_00112.jpg

Manage landside vegetation to allow inspection and access.

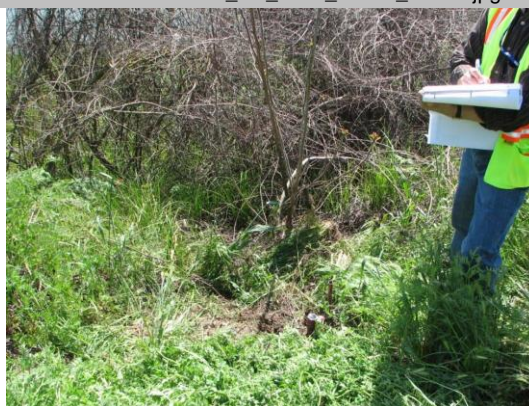
Photo 3 of 3 : UCIP_SP_2018_21613_36688.jpg

View of air valve located on waterward slope--dense vegetation limits inspection.

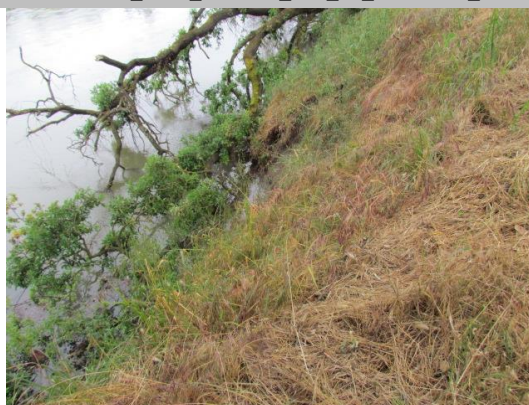
Photo 1 of 1 : SP_2018_RD0349_205_39_20180305_00029.jpg

RD 349 Unit 2 levee mile 0.35 waterside slope and shoulder.

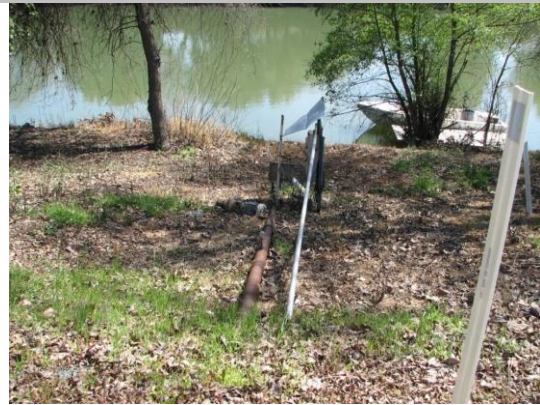
Photo 1 of 3 : UCIP_SP_2018_21615_36694.jpg

View of pipe and pump on waterward side.

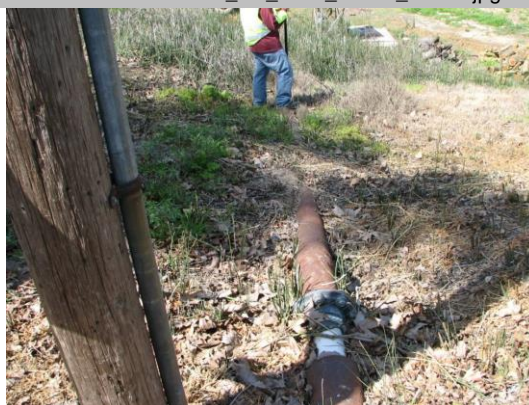
Photo 3 of 3 : UCIP_SP_2018_21615_36696.jpg

View of landward side--it appears PVC pipe was sleeved through existing crossing.

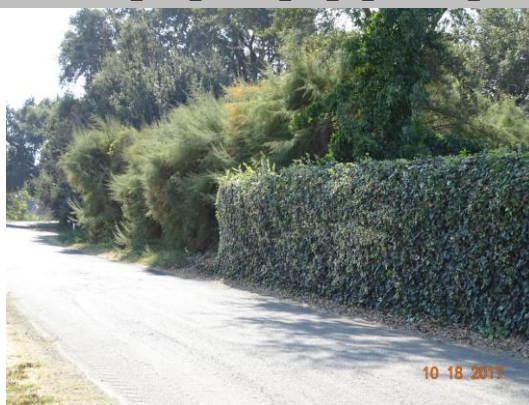
Photo 1 of 1 : SP_2018_RD0349_205_57_20180305_00048.jpg

Landside landscaping should be thinned and maintained to allow inspection and access to levee slope and toe.

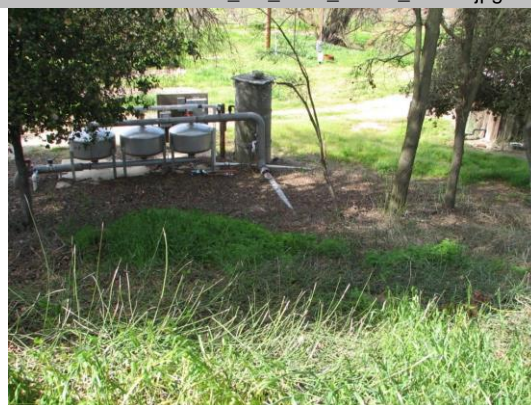
Photo 3 of 3 : UCIP_SP_2018_21607_36658.jpg

Filter system, control panel, and stand pipe located at the landward toe.

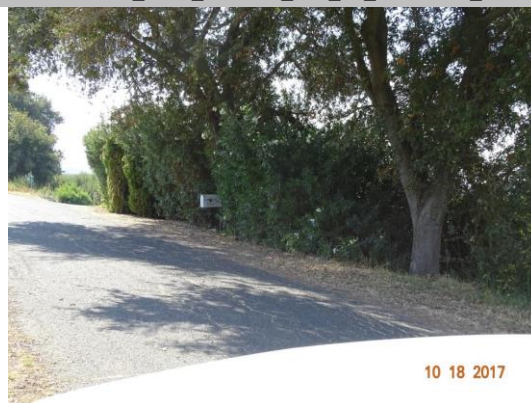
Photo 1 of 1 : SP_2018_RD0349_205_58_20180305_00049.jpg

Landside landscaping should be thinned and maintained to allow inspection and access to levee slope and toe.

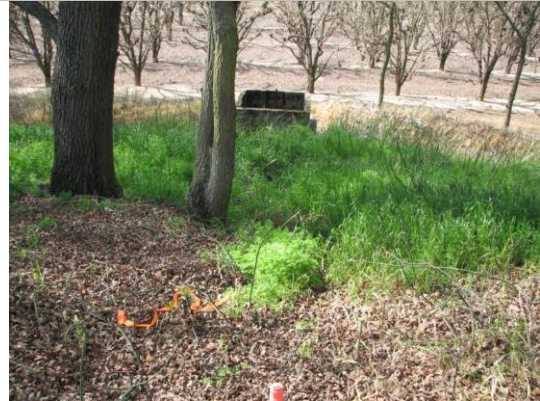
Photo 3 of 3 : UCIP_SP_2018_21609_36666.jpg

Overview of landward side--distribution box located at toe.

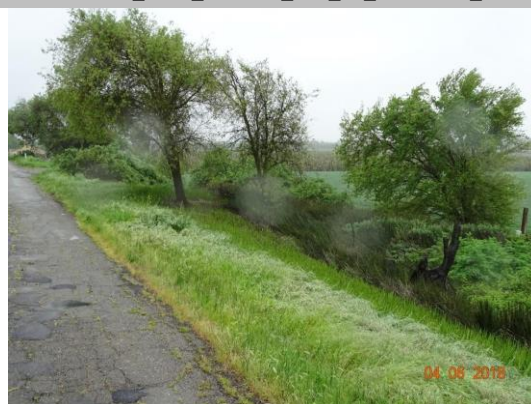
Photo 1 of 1 : SP_2018_RD0349_205_61_20180409_00117.jpg

LM Start	2.87	Rating **	U	Issue No.	61
LM End	2.92	Issue Type +	Ma	Location *	LS
Category	Earthen Levee			GPS Latitude/Longitude	
				Start	End
Item	Vegetation			38.269471 °	38.268743 °
				-121.589826 °	-121.589480 °
DWR ID	DWR_RD0349_02_f_2017_61				
Comment Code					
V2 : Remove the wild growth other than native grasses from the levee slopes.					
Inspector Comment					
Thick brush, vines, horsetail and grass block visibility and access. Should be cleared.

Manage landside vegetation to allow inspection and access.

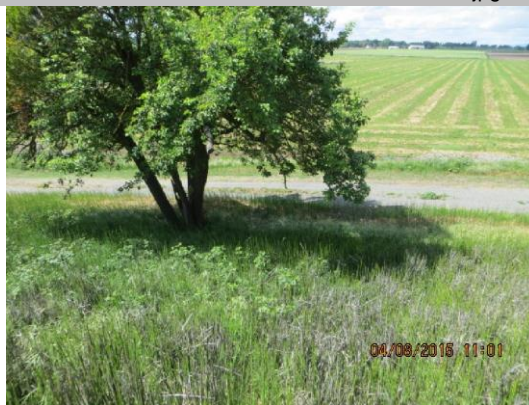
Photo 3 of 3 : UCIP_SP_2018_44328_73705.jpg

No pipe visible on LS toe.

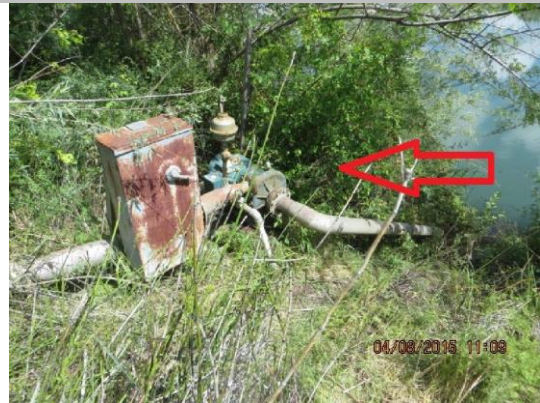
Photo 1 of 3 : UCIP_SP_2018_50015_73709.jpg

Abandoned pipe visible on slope in vegetation behind new pipe on WS slope.

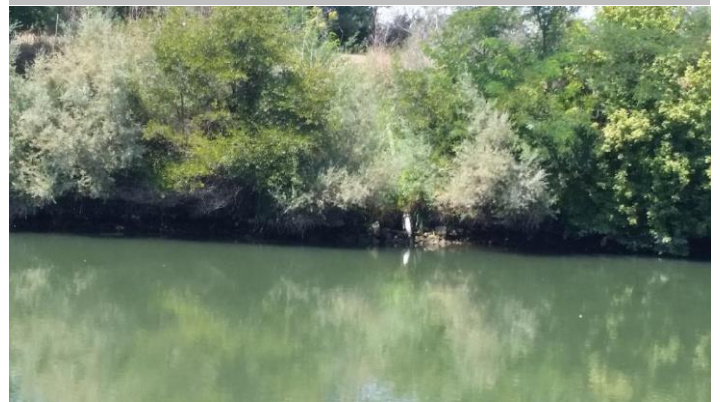
Photo 3 of 3 : UCIP_SP_2018_50015_75632.jpg

Pipe visible from opposite bank.

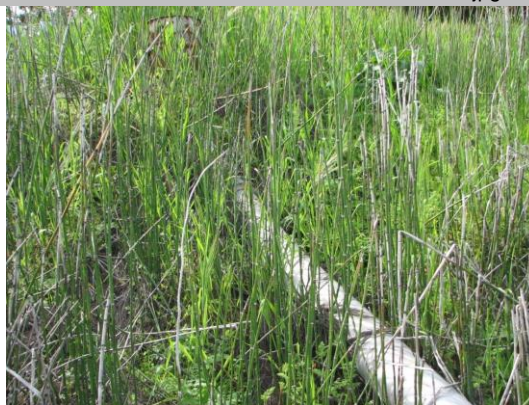
Photo 2 of 3 : UCIP_SP_2018_44332_36681.jpg

Pipe and Steel riser on WS slope.

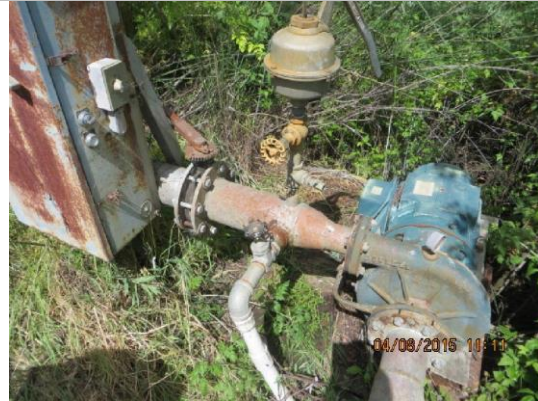
Photo 3 of 3 : UCIP_SP_2018_44332_73710.jpg

Butterfly valve next to, electrical panel, pump, and hand pump on WS slope.

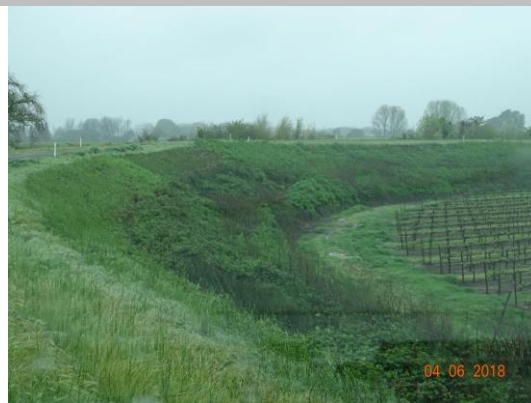
Photo 1 of 1 : SP_2018_RD0349_205_62_20180409_00119.jpg

Remove berry vines to allow inspection and access.

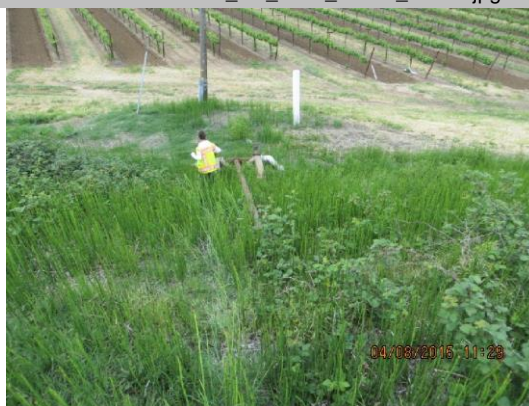
Photo 1 of 3 : UCIP_SP_2018_44333_73713.jpg

Pipe, distribution box, and power pole visible on LS slope/toe.

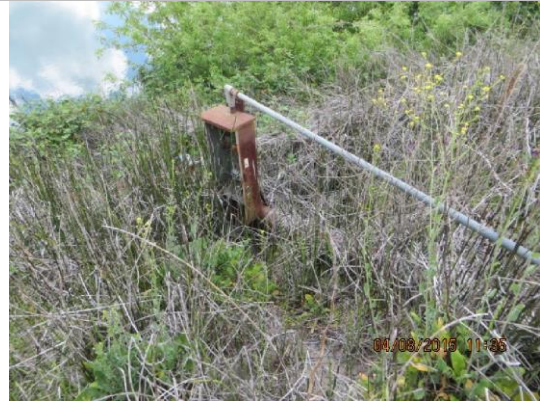
Photo 3 of 3 : UCIP_SP_2018_44333_73711.jpg

Pipe and electrical conduit visible on WS slope.

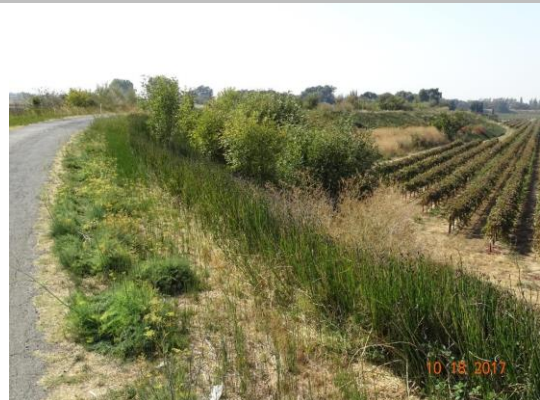
Photo 1 of 1 : SP_2018_RD0349_205_63_20180305_00053.jpg

Landside trees should be trimmed or thinned to allow inspection and access to levee slope and toe.

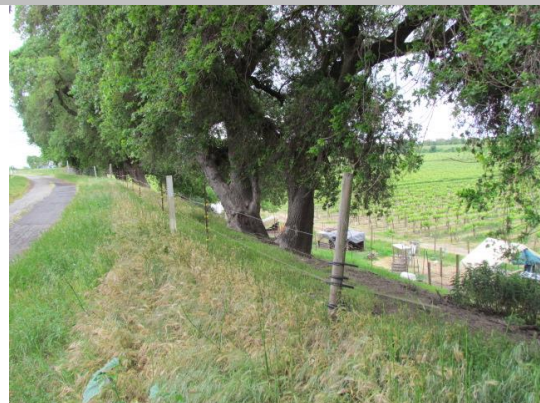
Photo 1 of 1 : SP_2018_RD0349_205_59_20180305_00050.jpg

Unauthorized electric fence installed along the shoulder and levee slope landside .

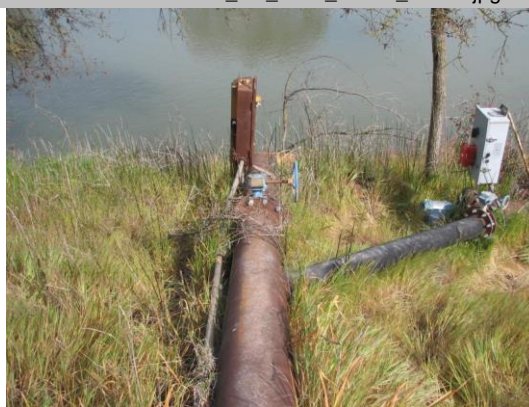
Photo 2 of 3 : UCIP_SP_2018_21612_36682.jpg

View of crossing on waterward side.

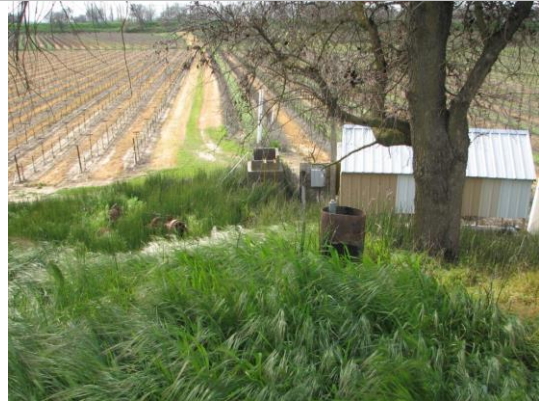
Photo 3 of 3 : UCIP_SP_2018_21612_36683.jpg

Overview of lanward side--appurtenances include distribution box, stand pipe, pump house, and control panel.

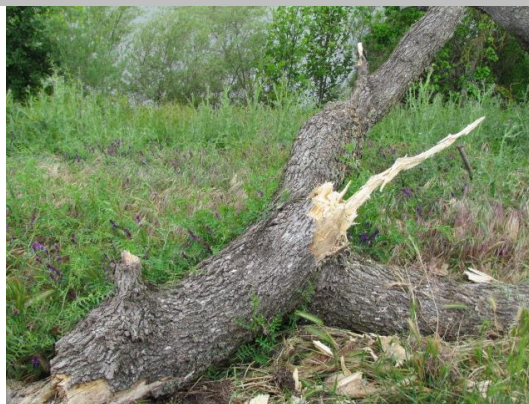
Photo 1 of 1 : SP_2018_RD0349_206_37_20180305_00008.jpg

RD 349 Unit 4 levee mile 0.04 Dead tree on the waterside shoulder and crown roadway.

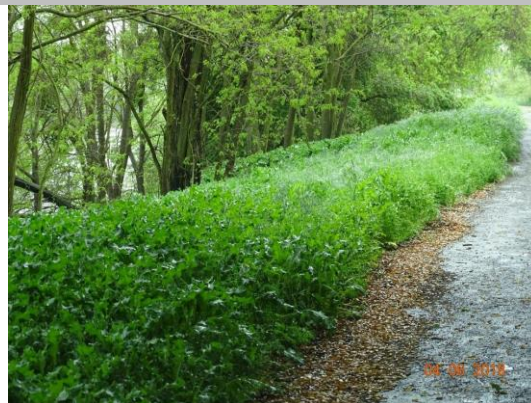
Photo 1 of 1 : SP_2018_RD0349_206_68_20180409_00089.jpg

Waterside vegetation should be reduced to 20' from crown.

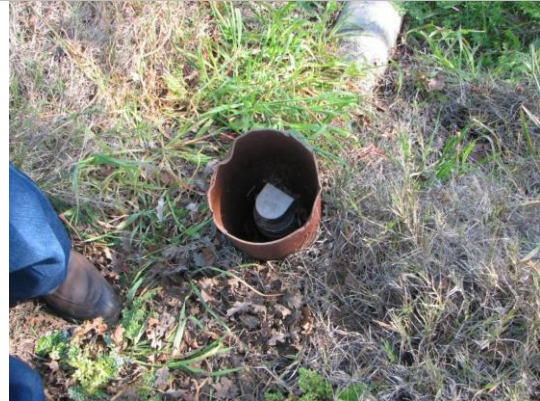
Photo 3 of 3 : UCIP_SP_2018_21673_36852.jpg

View of siphon breaker.

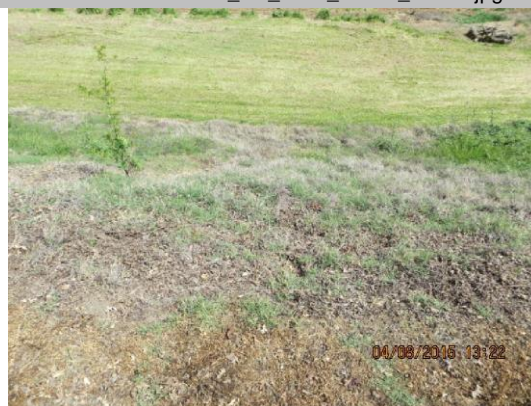
Photo 1 of 2 : UCIP_SP_2018_44335_73721.jpg

Pipe visible on LS slope.

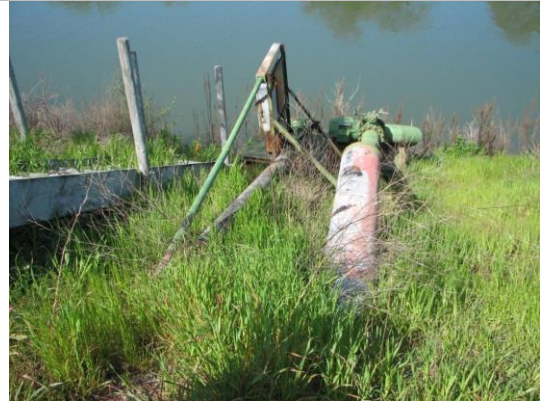
Photo 1 of 1 : UCIP_SP_2018_47043_36864.jpg

View of pipe, control panel, and stairs. 2 pipes go through levee 14-inch and 8-inch.

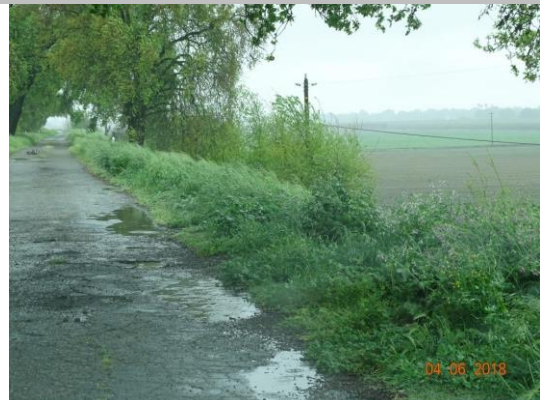
Photo 1 of 1 : SP_2018_RD0349_206_71_20180409_00092.jpg

Manage landside vegetation to allow inspection and access.

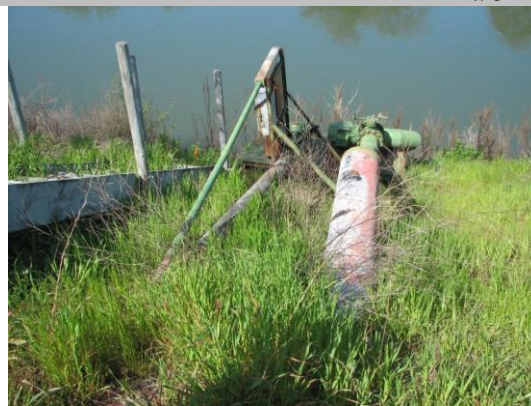
Photo 1 of 3 : UCIP_SP_2018_47042_36856.jpg

Pump system located on waterward side.

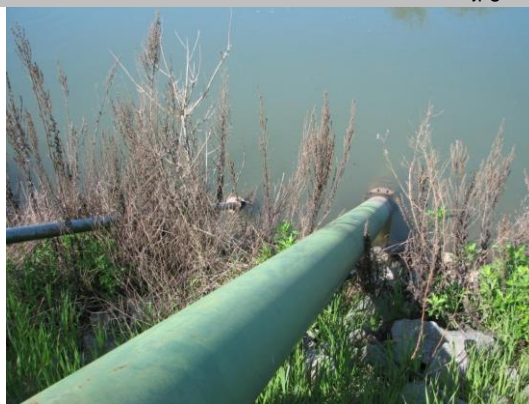
Photo 3 of 3 : UCIP_SP_2018_47042_36858.jpg

Rip rap along the waterward toe.

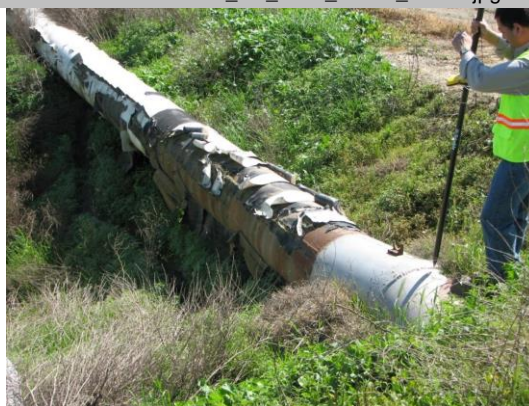
Photo 3 of 3 : UCIP_SP_2018_43445_36728.jpg

Pipe is wrapped--unwrapped coating.

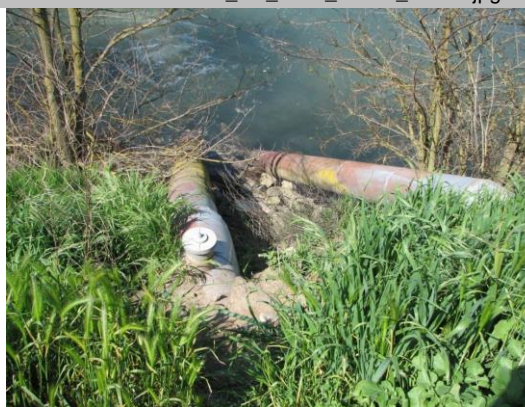
Photo 2 of 3 : UCIP_SP_2018_21632_36731.jpg

View of waterward side--2-24 inch pipes.

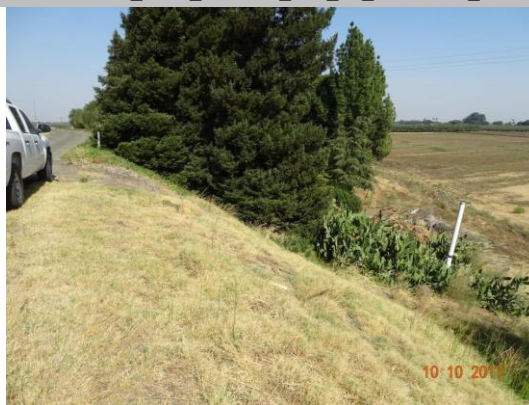
Photo 1 of 1 : SP_2018_RD0349_206_39_20180305_00009.jpg

Landscaping on landside at LM 1.67.

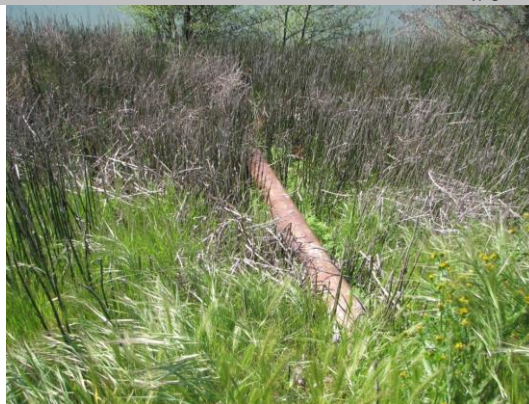
Photo 2 of 2 : UCIP_SP_2018_21634_36738.jpg

View of waterward side--dense vegetation limits inspection.

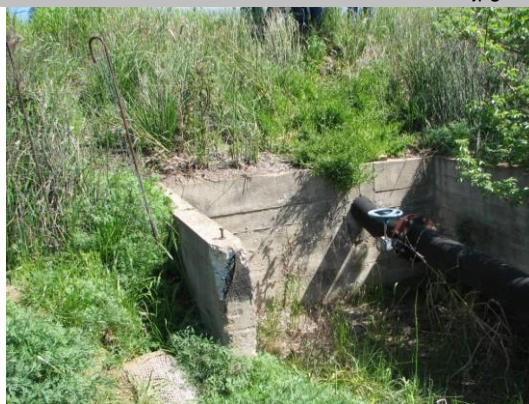
Photo 2 of 3 : UCIP_SP_2018_43424_36871.jpg

View of waterward side--headwall, pipe, and gate valve.

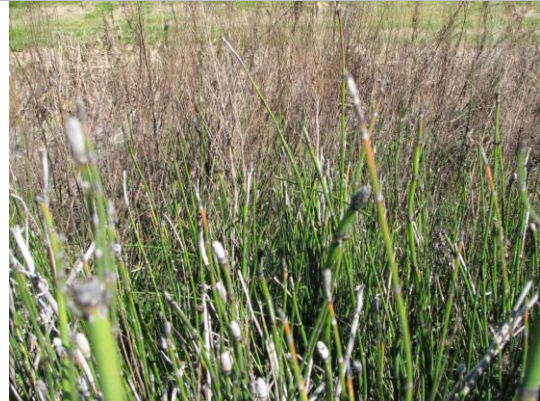
Photo 3 of 3 : UCIP_SP_2018_43424_36868.jpg

View of landward side--dense vegetation on slope limits inspection.

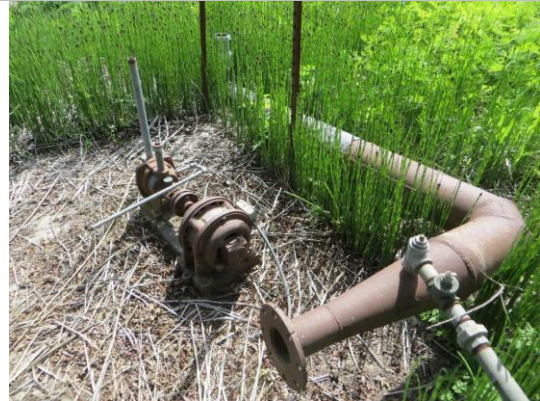
Photo 3 of 3 : UCIP_SP_2018_50014_73741.jpg

Abandoned pump at LS toe.

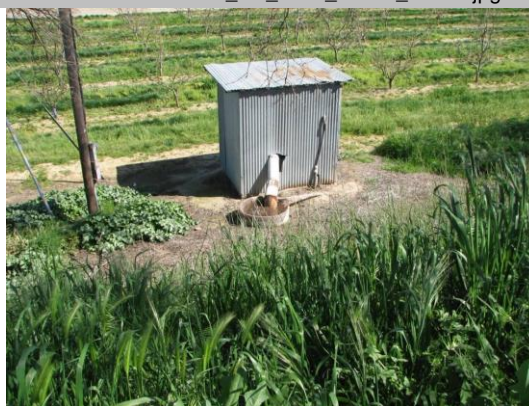
Photo 1 of 2 : UCIP_SP_2018_43455_36783.jpg

Pump house located on landward side.

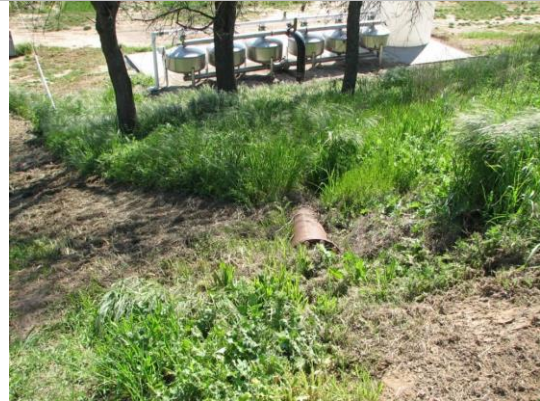
Photo 3 of 3 : UCIP_SP_2018_43457_36790.jpg

View of pipe and filter system on landward side.

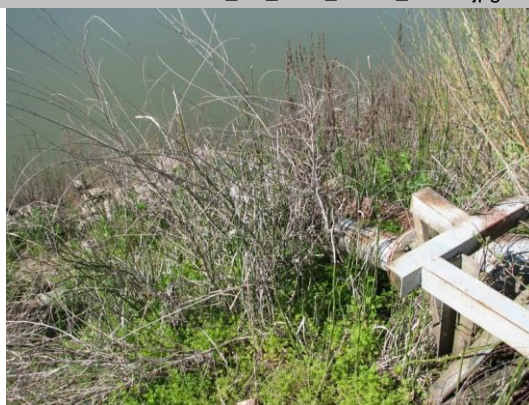
Photo 1 of 3 : UCIP_SP_2018_43459_36796.jpg

Waterward side--pipe visible through dense vegetation.

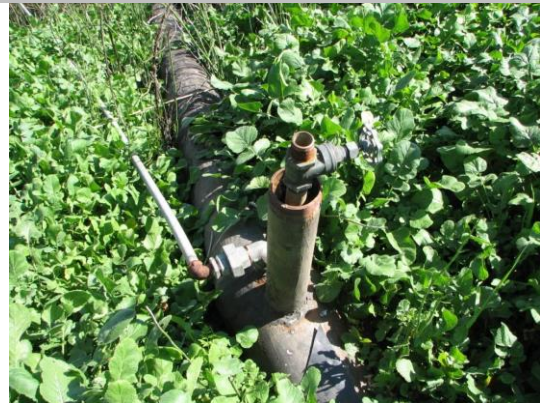
Photo 1 of 3 : UCIP_SP_2018_43431_36800.jpg

Air vent located on pipe on landward.

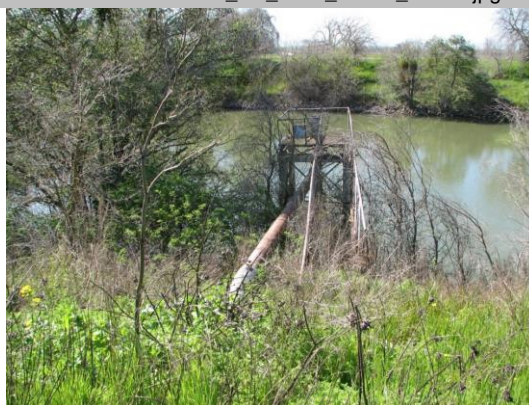
Photo 2 of 2 : UCIP_SP_2018_43433_70483.jpg

View of waterward side--pipe and remaining appurtenances.

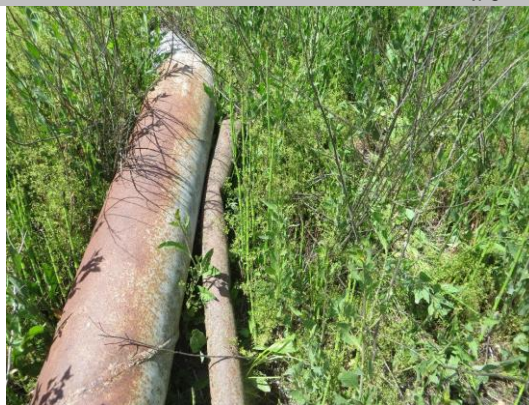
Photo 2 of 3 : UCIP_SP_2018_44391_73748.jpg

4-inch pipe next to larger pipe on LS slope.

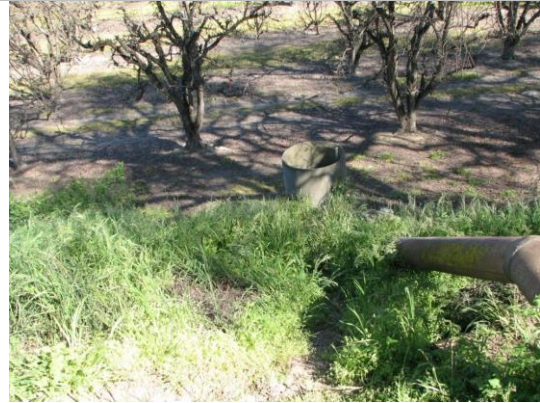
Photo 1 of 3 : UCIP_SP_2018_50016_36841.jpg

View of LS--pipe and stand pipe visible.

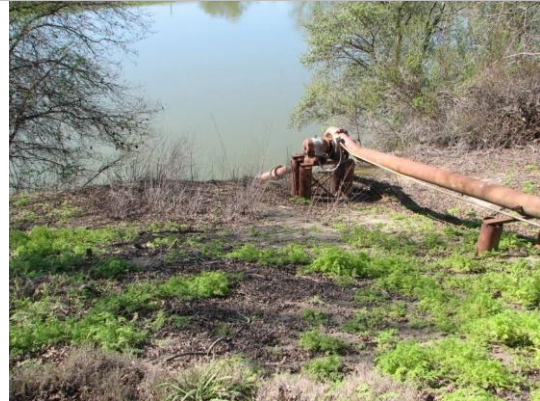
Photo 2 of 3 : UCIP_SP_2018_50016_36843.jpg

View of pipe and pump along WS slope.
